Conceptual Design Sunnyview Stream Restoration and Water Quality Improvements

Harford County, Maryland
McCormick Taylor Project No. 5067-01

July 2, 2007
Revised October 12, 2007
Final Report November 27, 2007

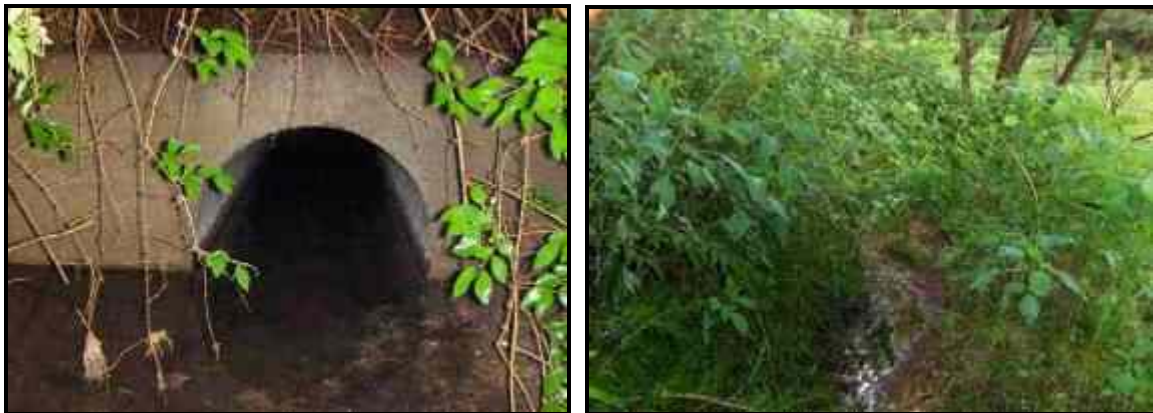
Site 1 is located immediately upstream of the unnamed tributary crossing under East Ring Factory Road. The 36" bituminous coated CMP storm drain outfall, refer to photo on left below, is located in the yard of 920 Fallen Stone Court. According to Gracelyn Section 1 As-Built Plans, dated April 1990, an infiltration device and gabion outlet was constructed at the culvert outfall. Due to the standing water observed during the site investigation, the infiltration device is not working properly and is clogged with sediment. The area draining to this site is approximately 18.9 acres and consists of residential areas. Approximately 47.7% (9.05 acres) of the drainage area is impervious.

The discharge from the storm drain system flows south along the East Ring Factory Road embankment towards the stream channel for approximately 70 feet. This area is well vegetated and appears stable, (photo below, right). Ponded water was observed at the outfall and in the pipe.

This site may be considered a good candidate for a BMP retrofit due to the large amount of impervious area draining to the site. However, the entire drainage area is fairly large and the outfall area is currently stable, providing some vegetative treatment of the discharge prior to entering the tributary, making it less in need of water quality improvements relative to some other sites.

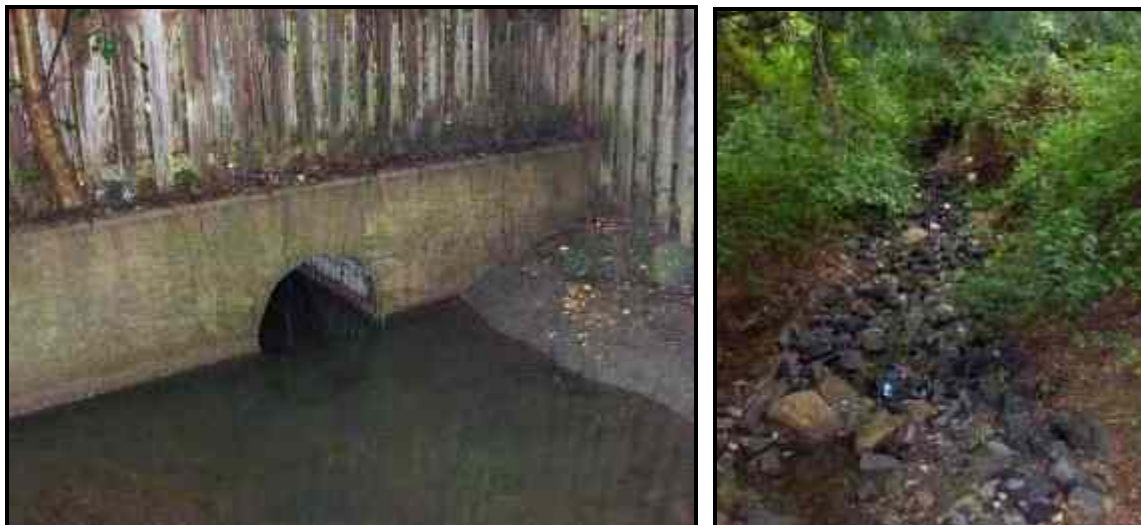
Site 2 is located immediately upstream of the unnamed tributary crossing under East Ring Factory Road, across the tributary from Site 1 (outfall channels from Site 1 and Site 2 join the tributary at same river station on opposite banks - Site 1 on the north bank, Site 2 on the south bank). The 30" bituminous coated CMP storm drain outfall is located in the yard of 418 Sunnyview Road.

According to Gracelyn Section 1 As-Built Plans, dated April 1990, an infiltration device and gabion outlet was constructed at the culvert outfall. Due to the standing water observed during the site investigation, the infiltration device is not working properly and is clogged with sediment. The entire outfall is fenced; refer to photo above, left. The area draining to this site is approximately 19.7 acres of residential area. Approximately 26.1% (5.16 acres) of the drainage area is impervious.

The discharge from the storm drain system flows along the East Ring Factory Road embankment towards the stream channel for approximately 90 feet. The channel is lined with riprap and appears fairly stable; refer to photo on right above. One deep area of erosion was observed approximately half way between the pipe outfall and the tributary where the bed material had been washed out from under the geotextile fabric and riprap. The channel is fairly flat and the banks have woody vegetation. A large amount of ponded water was observed at the outfall and in the pipe. Debris is beginning to build up in the fence located in the outfall channel, causing a partial blockage of flow.

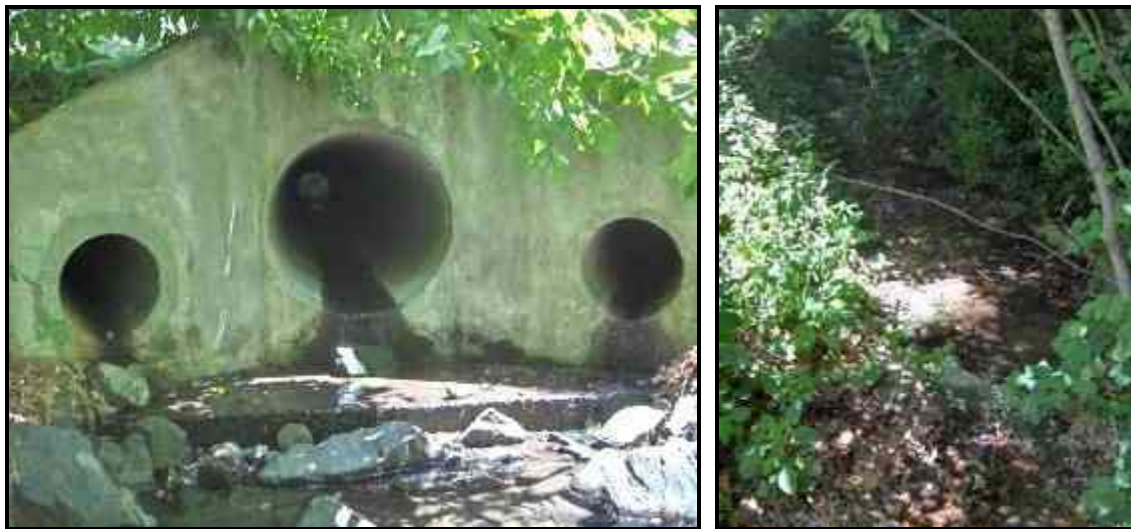
Site 3 is located at 208 East Ring Factory Road. Two 18" RCP pipes and one 36" RCP pipe, refer to photo on left below, outfall convey storm drain runoff along the east side of the property for approximately 175 feet before discharging into the tributary. The outfall is stable and protected with riprap. Base flow in the pipe during the field investigation may indicate Waters of the US. The area draining to this site is approximately 8.9 acres and consists of residential areas. Approximately 15.7% (1.40 acres) of the drainage area is impervious.

The outfall channel appears stable but is fairly steep; refer to photo on right above. The property owners have constructed a small pedestrian bridge near the house to access the other side of the outfall channel.

Although this may have appeared to be a possible location for a BMP facility based on the criteria, the slope of the outfall channel and permitting concerns due to the possible Waters of the US, this is a less favorable candidate for BMP placement.

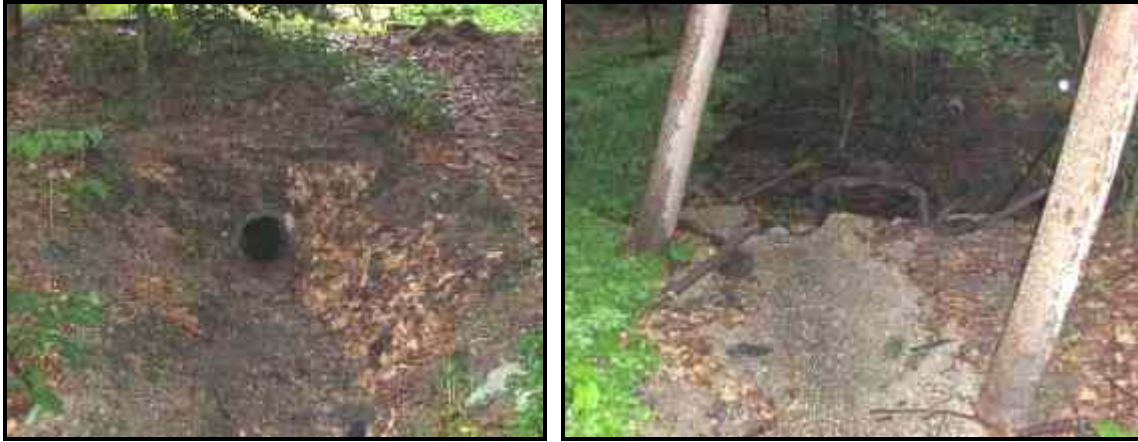
Site 4 is located between 113 and 115 Colony Place. A 12" RCP storm drain system outfalls behind a fence into a concrete channel; refer to photo on left below. The concrete channel follows the slope of the adjacent ground before steeply dropping approximately 3-4' into the streambed; refer to photo on right below. However, the stream bank is lined with a mix of riprap and stone at this connection.

Based on the GIS information and the field verification, it appears the outfall pipe may have been extended. The concrete channel is approximately 20 feet. The area draining to this site is approximately 2.9 acres and consists of residential areas. Approximately 32.2% (0.94 acres) of the drainage area is impervious.

Due to the percentage of impervious area draining to this area and potential for increased outfall stability, we believe this site is a good candidate for a BMP facility or outfall improvement. Currently, any sediment or debris conveyed within the stormwater runoff is conveyed directly into the tributary and the tributary embankment is eroding at the steep drop. Removing the concrete channel and stabilizing the embankment at the confluence would reduce the sediment entering the tributary.

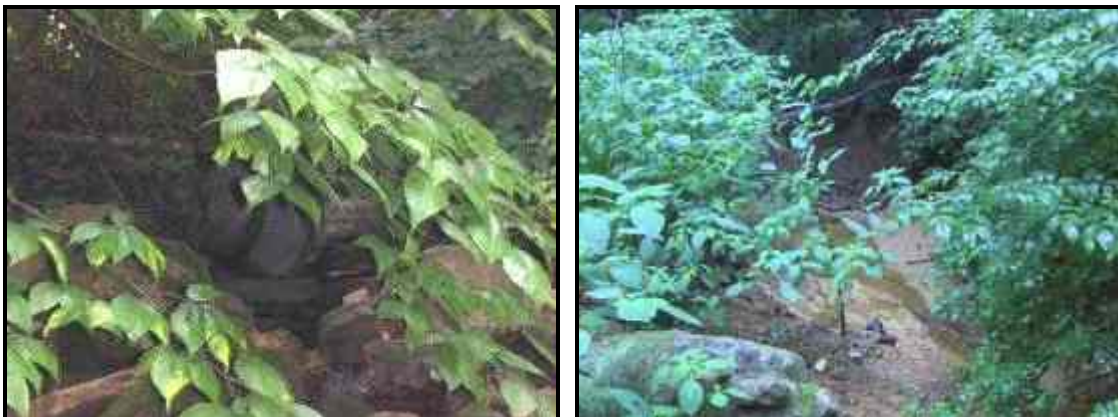
Site 5 is located in the backyard of 130 Fairmont Drive. This site was selected based on the GIS data; however the pipe outfall could not be located in the field. The area surrounding the tributary in this location was heavily vegetated in the vicinity of the storm drain outfall. The tributary appeared to flow through two culverts upstream of where the culvert for Site 5 was supposedly located; refer to photo on left below. The tributary appeared stable with bedrock; refer to photo on right below. It could not be determined if the GIS data was incorrect or if the existing pipe had been blocked.

The area draining to the site is approximately 24.5 acres and consists of residential areas. Approximately 27.6% (6.75 acres) of the drainage area is impervious. Further investigation, including additional property access permission through this property, is recommended. At this point, it can not be determined whether this site is a good candidate for a BMP facility.

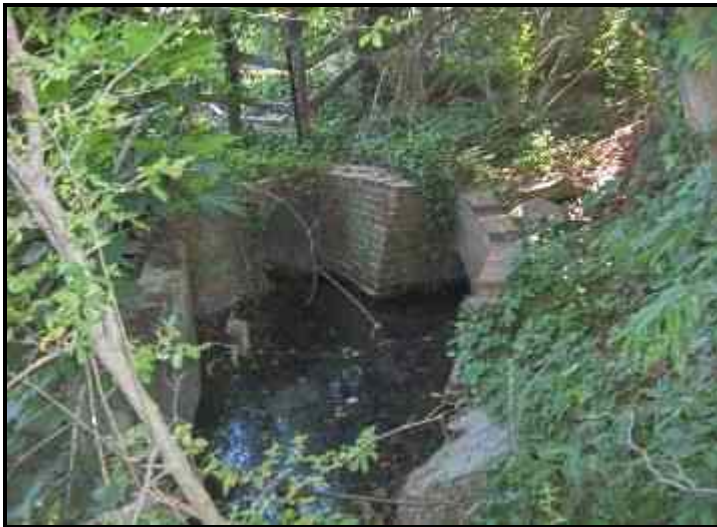
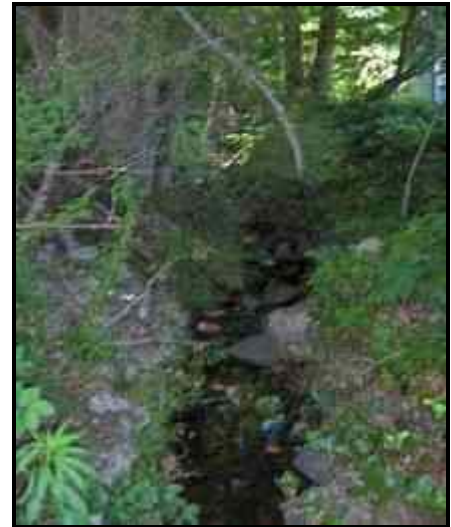
Site 6 is located in the backyard of several properties along East Ring Factory Road and Vermont Road. Two separate storm drain systems outfall into a single outfall channel, which conveys flow towards the east approximately 150 feet to the tributary. A combination brick and concrete endwall has been constructed at the outfall; refer to photo on left below. Ponded water was observed at the outfall and in the adjacent channel, however both areas appear stable.

The primarily residential area draining to this site is approximately 44.0 acres. Approximately 22.8% (10.04 acres) of the drainage area is impervious. This site may be considered a good candidate for a BMP facility due to the large amount of impervious area draining to the site. The outfall channel is stable; however there is no removal of sediment prior to the confluence with the tributary. Refer to photo on right below. Environmental permits may be required for work within the channel since ponded water (possible Waters of US) is present.

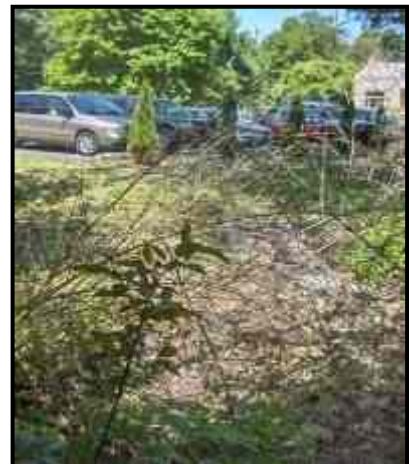
The homeowner at this location had mentioned the adjacent property owners at 1115 Emmorton Road had recently paved an additional parking lot on their property, causing runoff to flow towards the problem area. A small yard inlet was installed; however it is not located in the sump location and does not

intercept the parking lot runoff. Based on the GIS data, runoff from Sherwood Place should flow towards Emmorton Road; however it has been blocked by development. Further investigation of the ponding water and the possible effect of the adjacent development, for the benefit of the property resident, is recommended at this location. At this point, it can not be determined whether this site is a good candidate for a BMP facility, though the impervious area is small relative to other available sites.

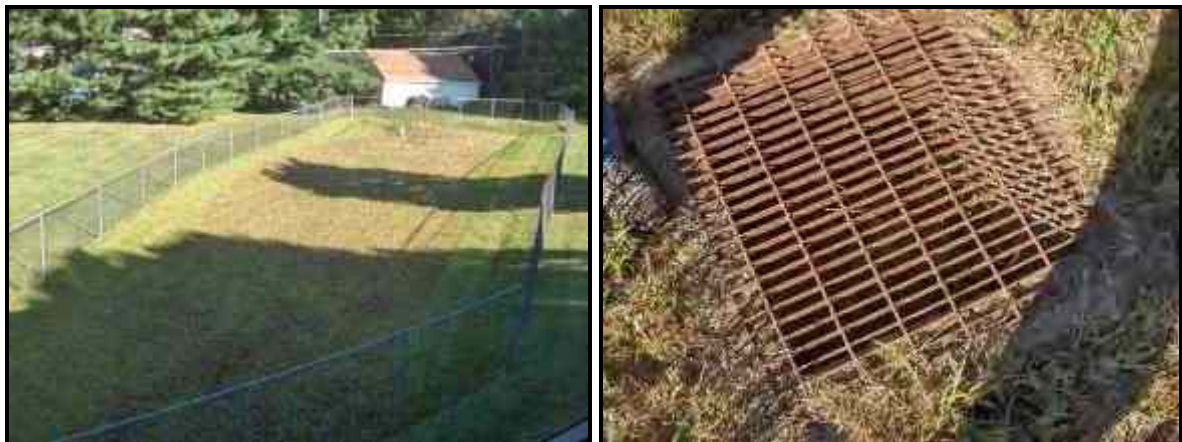
The facility appears well maintained with minimal standing water in the cleanout pipe. The stormwater inlet (below, right) does have some sediment accumulation, but appears to be infiltrating properly. A discussion with an employee of the church confirmed that the facility is maintained and does function properly in all but “historic level” (Tropical Storm Isabel was noted as one such event) rainfall events. Based on precipitation data (www.weatherunderground.com), the Bel Air area received approximately 0.05” of rain two days before our September 17th investigation; a total of 0.35” in the week preceding.

Although this was considered a possible location for a BMP retrofit based on the criteria, the facility is in good condition, appears to be continually maintained and is working properly. The cost of retrofitting this facility would not be justified by the minimal additional water quality benefits.

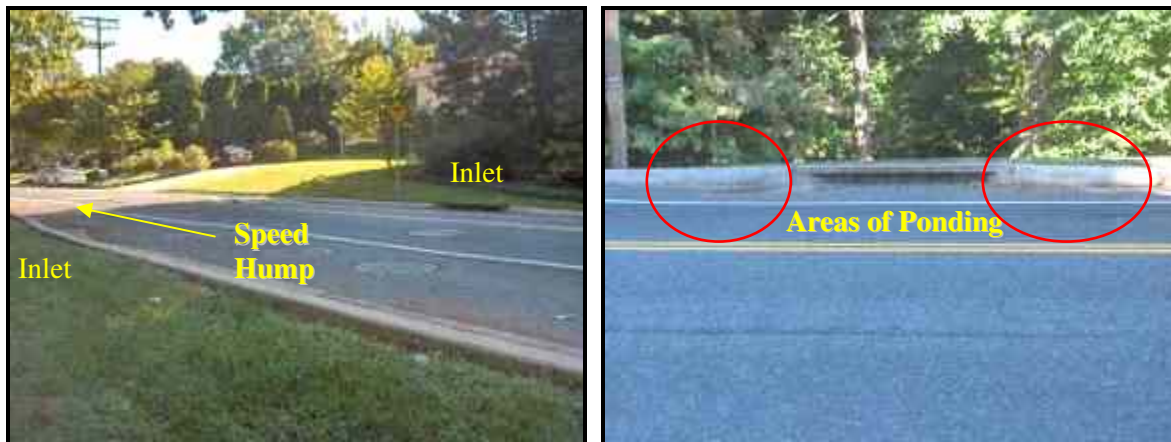
The first location is at 208 East Ring Factory Road. Two combination inlets are located immediately upstream of a speed hump (photo below, left). It appears that the gutter pan has cracked and settled around both inlets, causing runoff to pond adjacent to the grates in the low areas (photo below, right). Based on the field investigation, several additional localized low points are located along the gutter line on both sides of the roadway.

The inlets appear in good condition and are clean of debris and sediment. The inlets convey runoff into a culvert under East Ring Factory Road, which discharges at Site 3.

The failure of the pavement and pavement subgrade in localized areas appears to be the cause of the ponding issues outlined in the two sites above. These problems are best addressed as part of a pavement improvement or resurfacing project or task. By patching the areas with failing subgrade and/or gutter pan and resurfacing, low areas can be eliminated, providing positive flow towards the existing inlets.

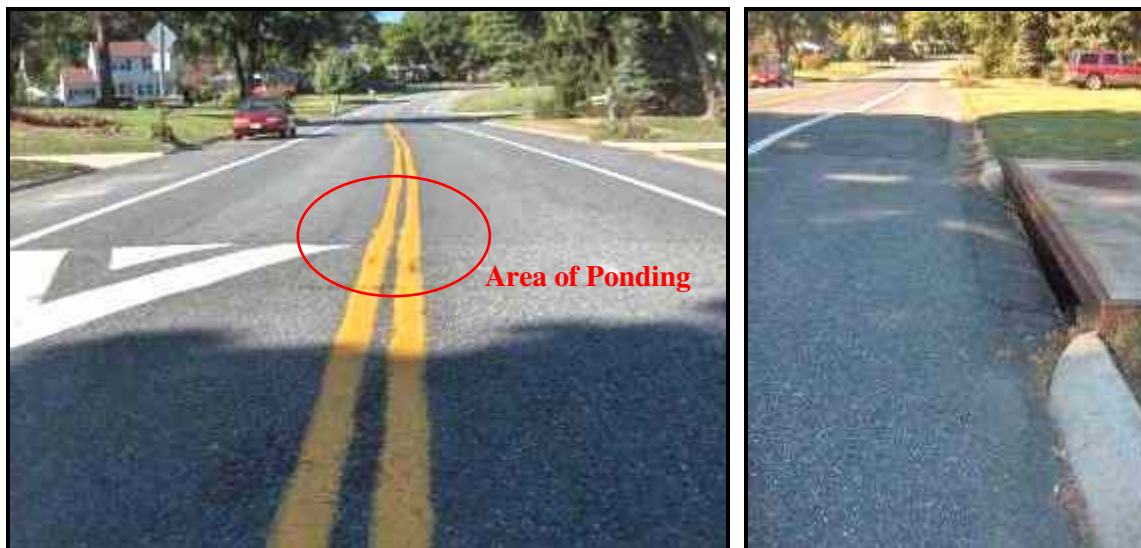
The second location is at 102 East Ring Factory Road. Two inlets are located immediately downstream of a speed hump. Roadway runoff is conveyed along the gutter pan into the inlets. However, it appears that the center of the roadway has settled upstream of the speed hump (photo below, left) causing runoff to pond in this location rather than flow towards one of the inlets. Based on field observation, it appeared that the inlet on the west side of the roadway may not be located at the sump (photo below, right).

The inlets appear in good condition and are clean of debris and sediment. The inlets convey runoff into a culvert under East Ring Factory Road, which discharges at Site 6.

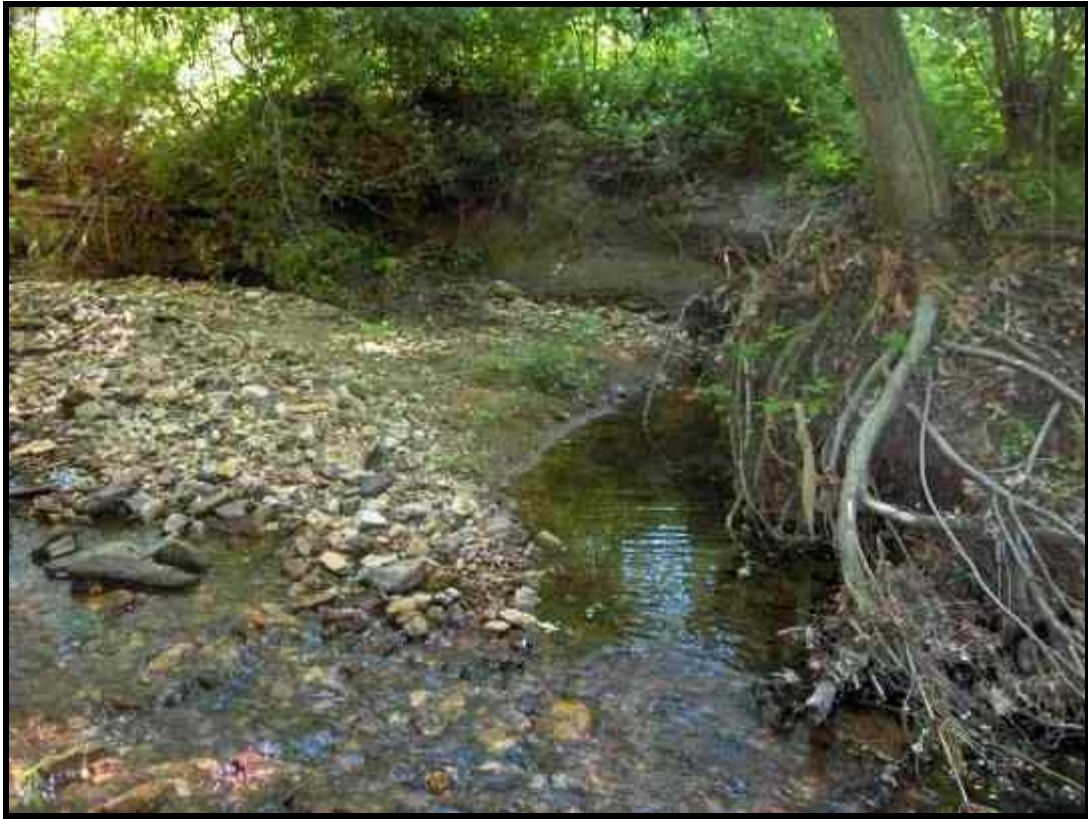
Photo 5 – View of bank erosion along the upstream right bank located just upstream of the downstream proposed work limits

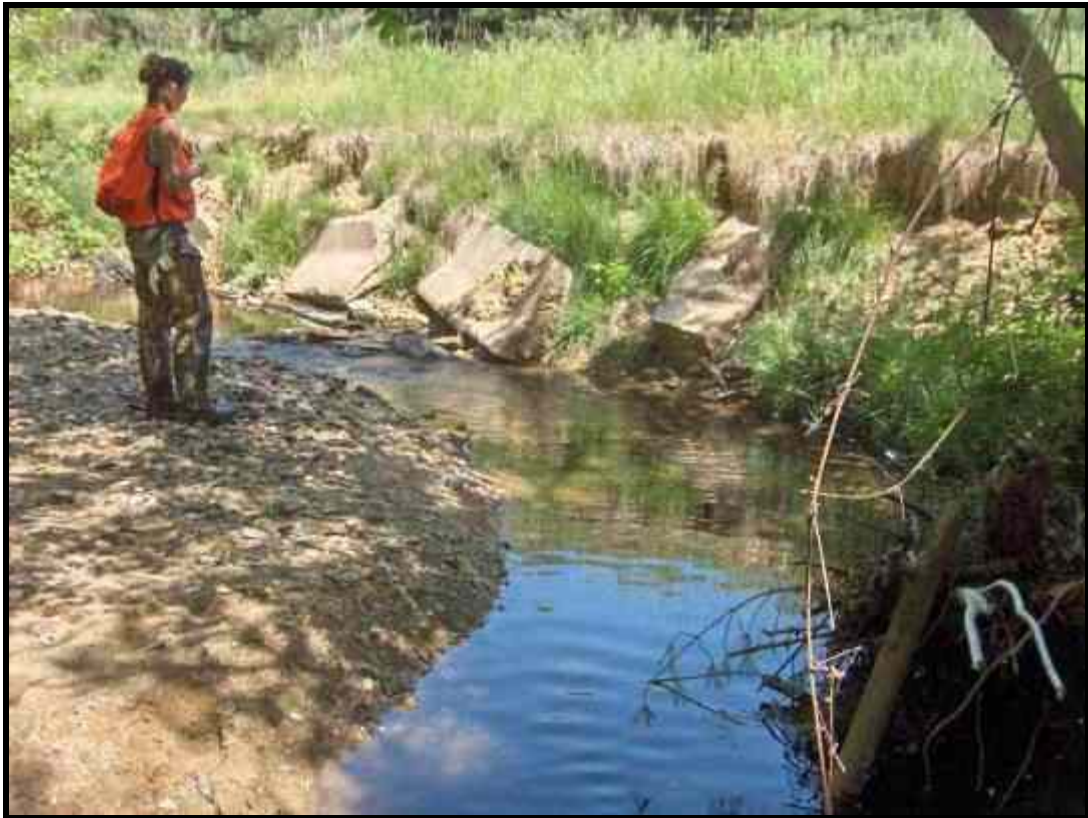
Photo 6 – View of concrete placed along the upstream right bank located just upstream of the downstream proposed work limits

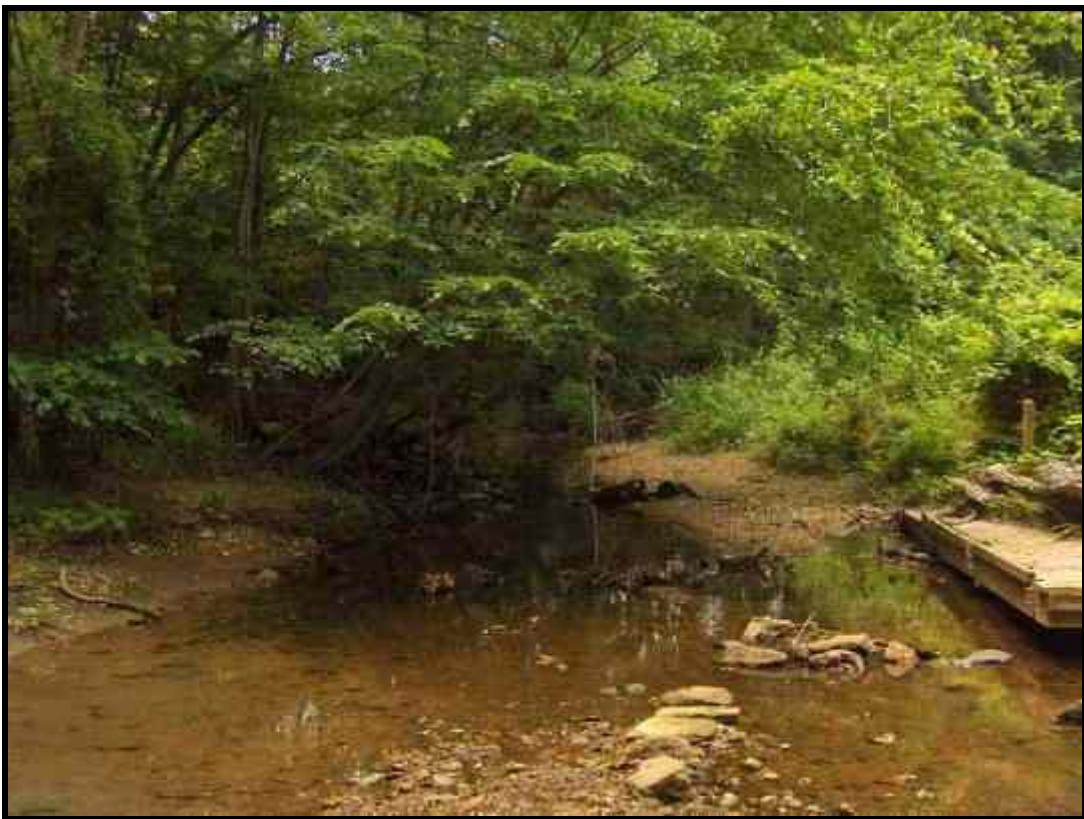
Photo 8 – Representative view (facing upstream) of an over-widened section within a wooded riparian zone

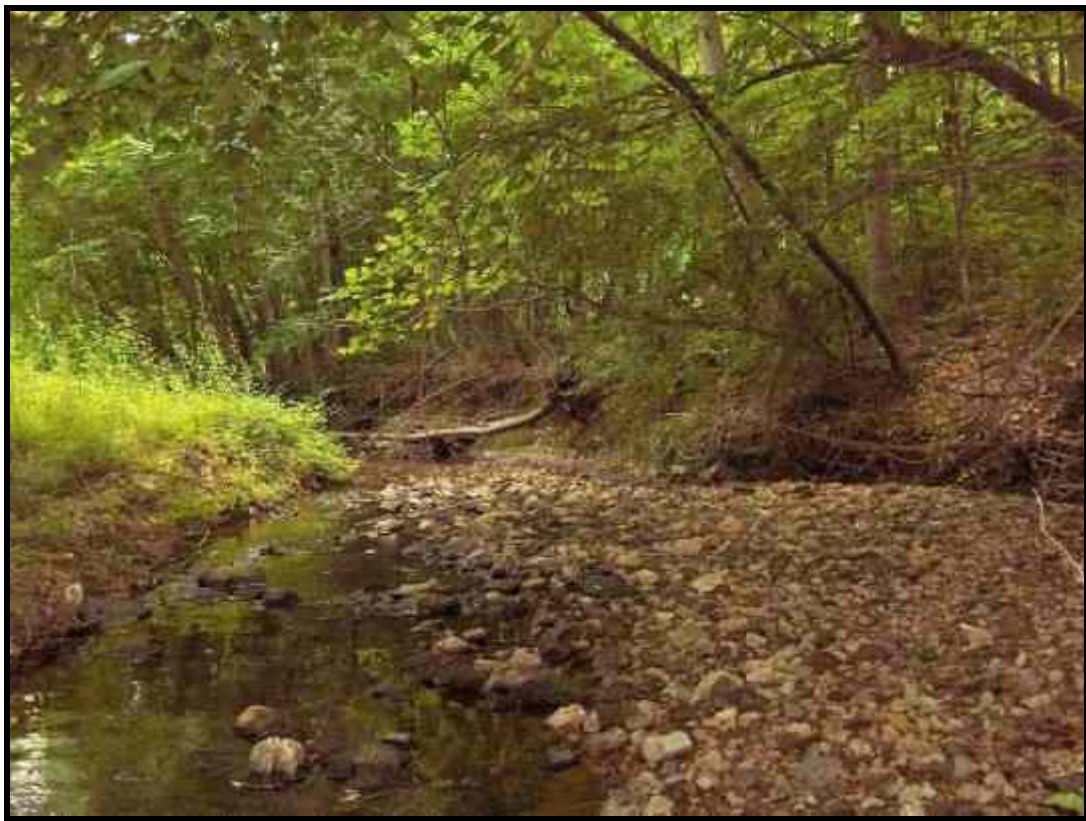
Photo 9 – Representative view (facing downstream) within a wooded riparian zone — note the sediment deposition

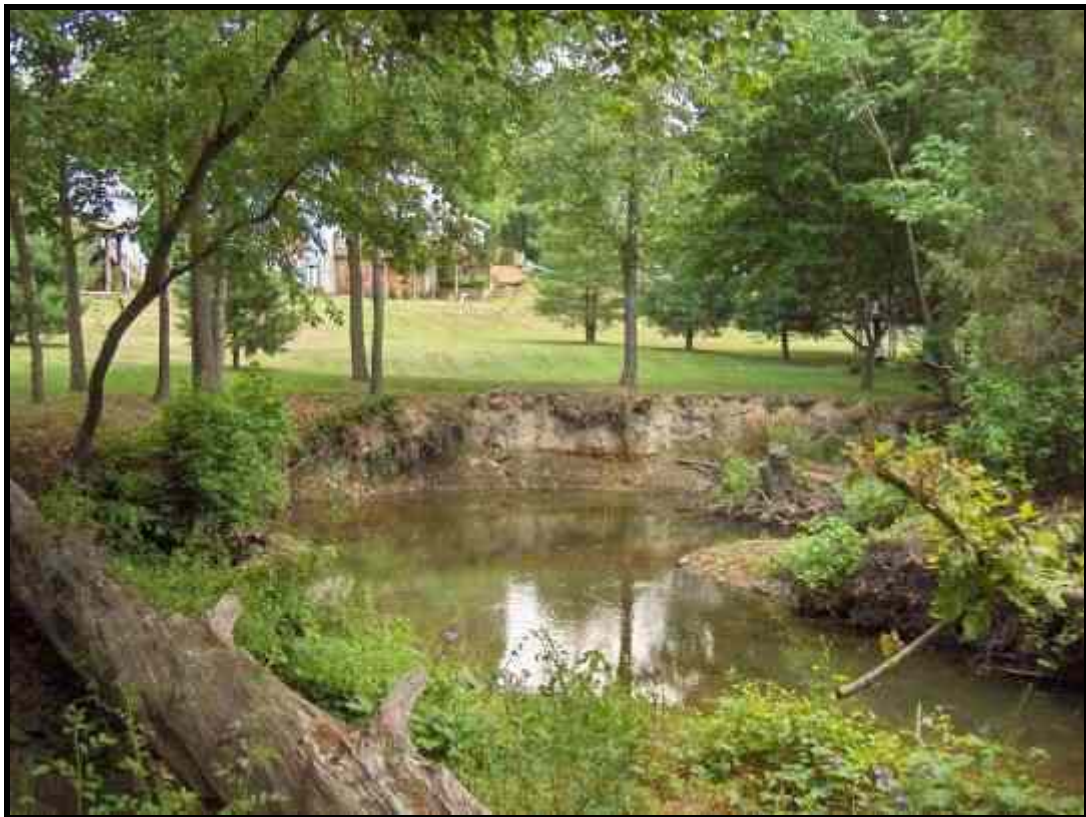
Photo 12 – Downstream view of bank erosion along a tight meander bend

Construction access to stabilize the bank erosion due to the tight meander bend geometry located between 50 and 200 feet upstream of the Option A work limits is recommended from Jackson Boulevard. A clearing in the riparian forest exists along the northwestern side of the channel, which would provide satisfactory construction access. This construction access would allow for stabilization of isolated areas of bank erosion between Options A and B. One area of bank erosion that would benefit from stabilization is located directly adjacent to Jackson Boulevard that, if left in its current state, would continue to erode and potentially undermine part of the road. Extending stream restoration activities to the Option B location is presented based on the bank erosion and tight meander bend geometry located between 50 and 200 feet upstream of Option A and construction access from Jackson Boulevard.

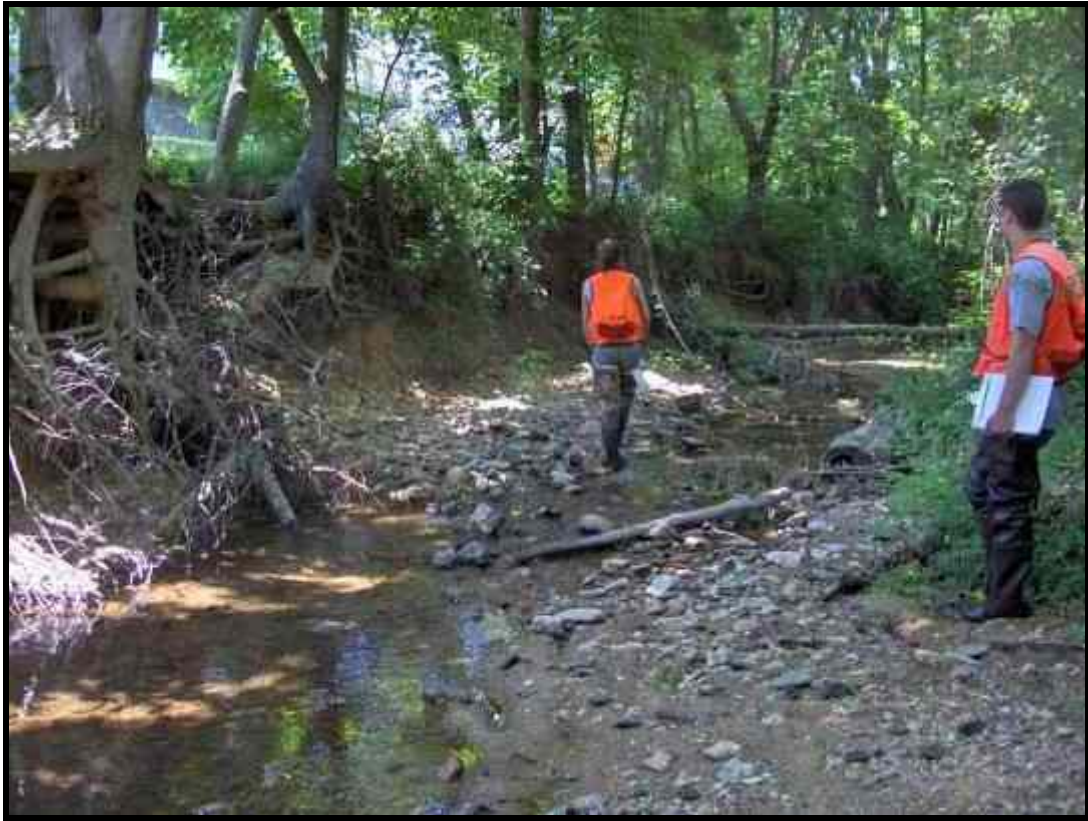
Photo 17 – Upstream view of bank erosion—note exposed roots

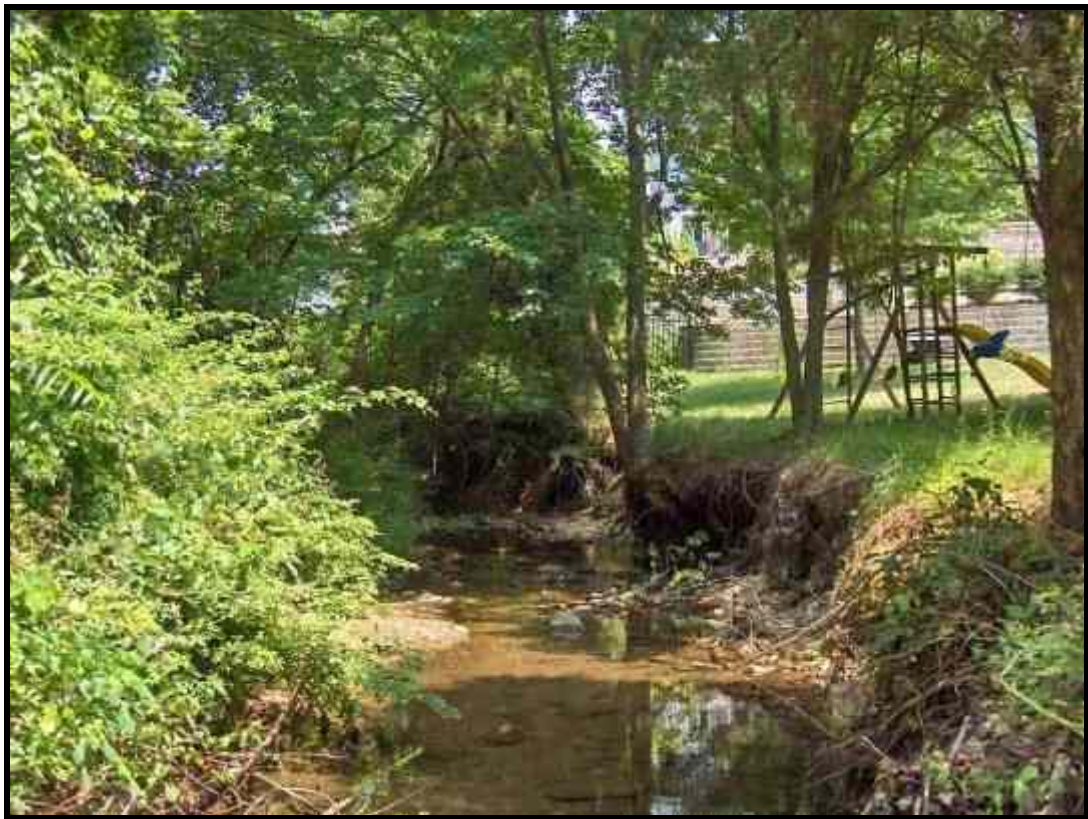
Photo 18 – Downstream view of bank erosion along a residential yard

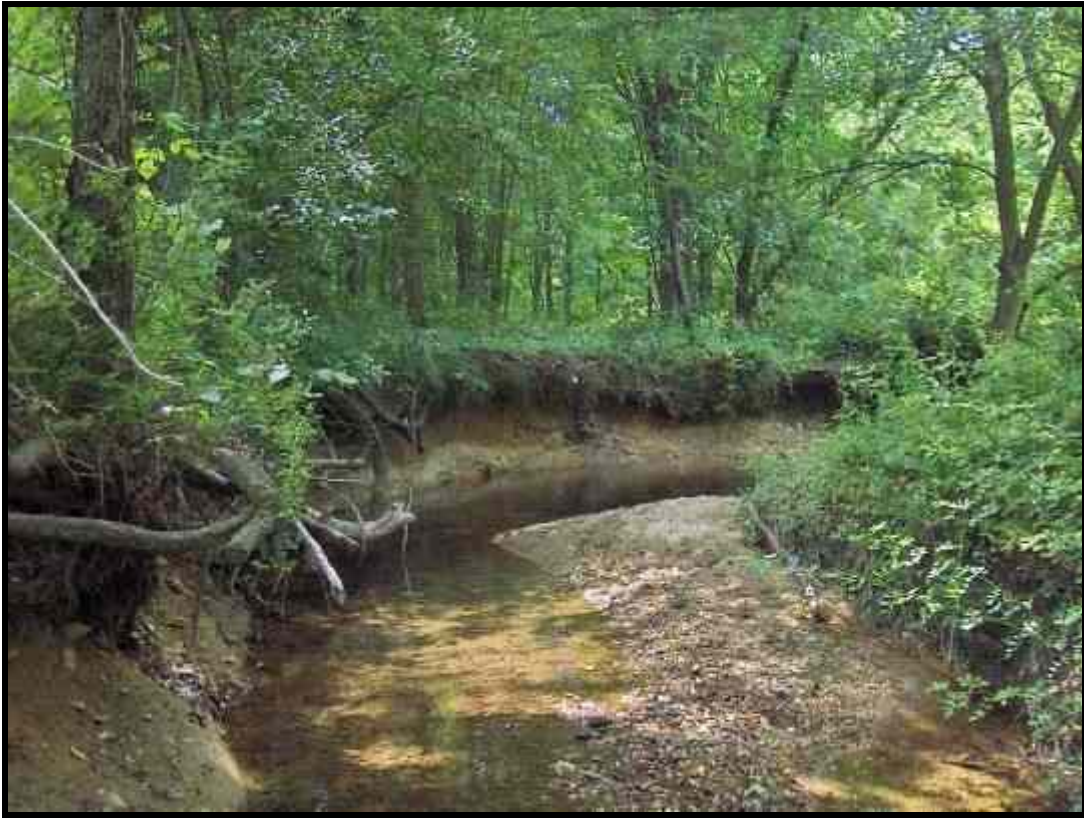
Photo 21 – Facing upstream toward bank erosion located just upstream of Option A of the upstream proposed work limits

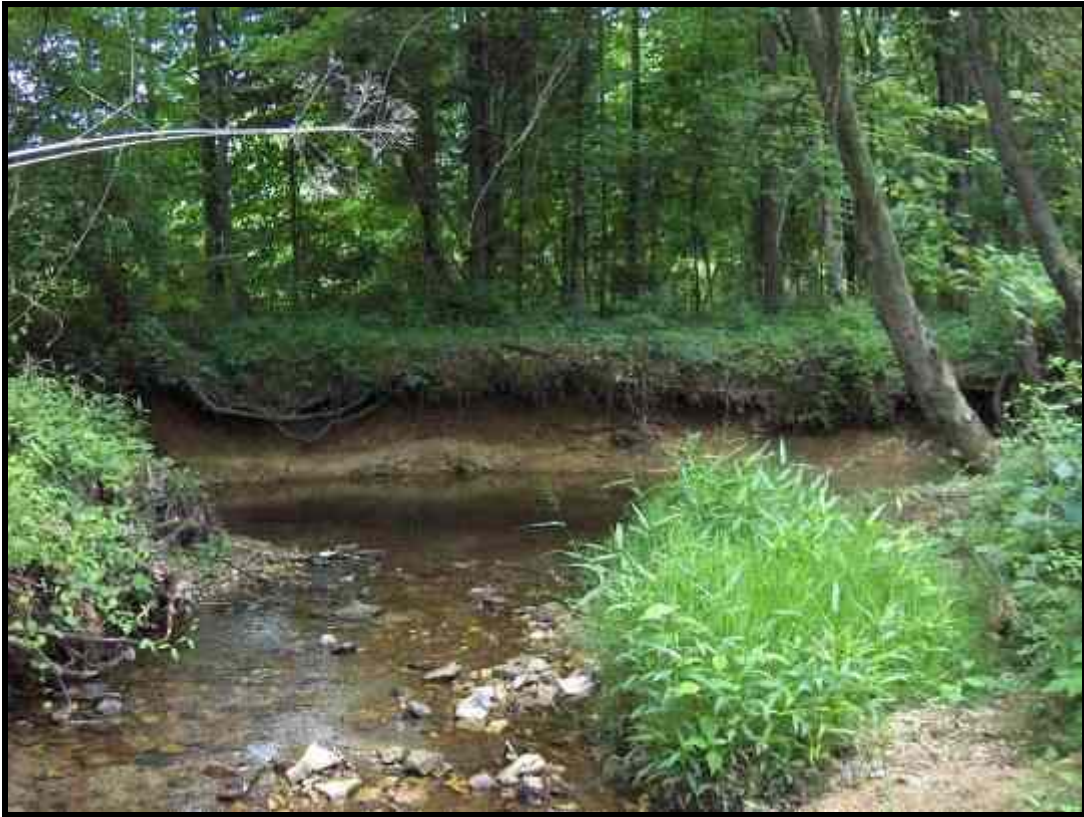
Photo 23 – Facing downstream toward bank erosion located just upstream of Option A of the upstream proposed work limits

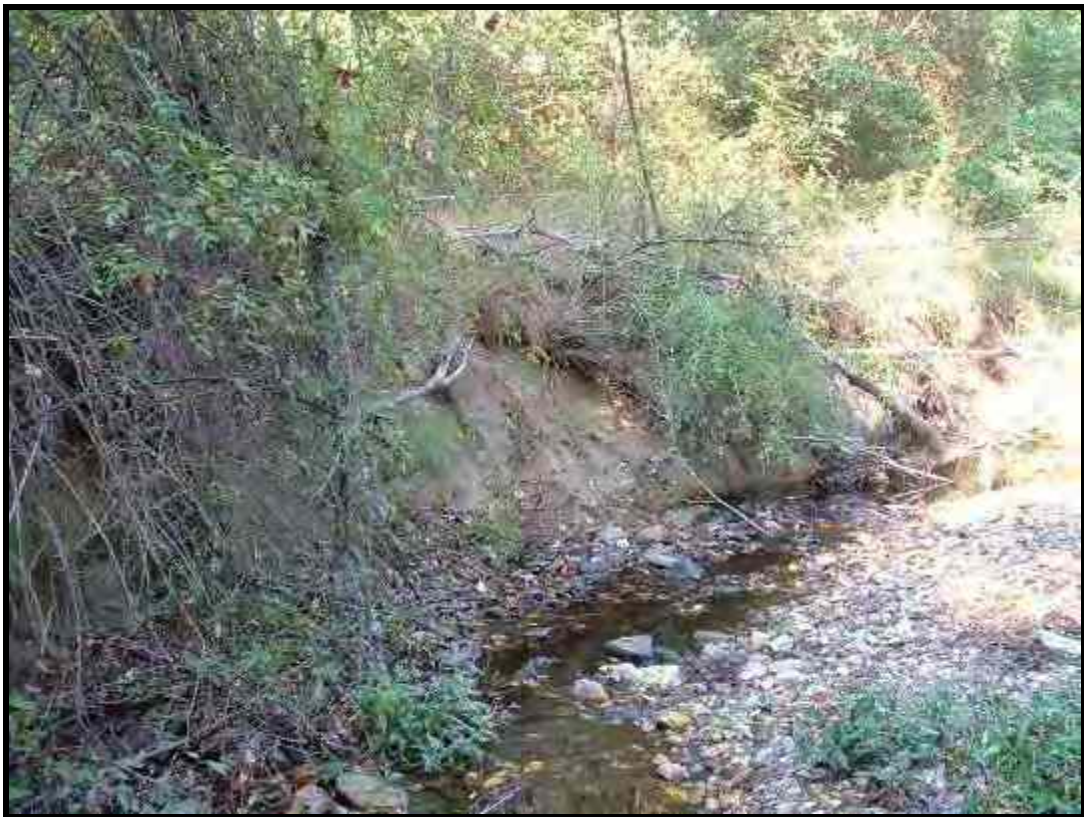
Photo 26 – Downstream view of bank erosion where established woody vegetation along the top-of-bank line is absent

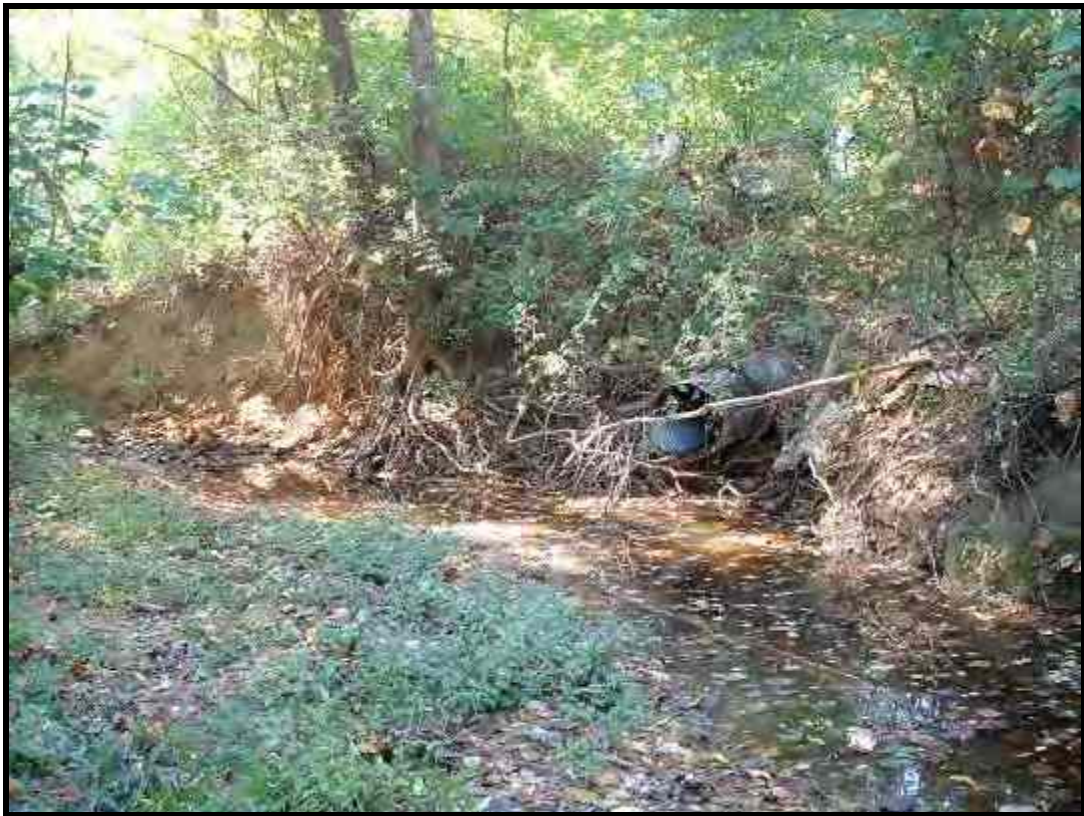
Photo 27 – Upstream view of an eight-foot high eroding streambank located directly adjacent to Jackson Boulevard

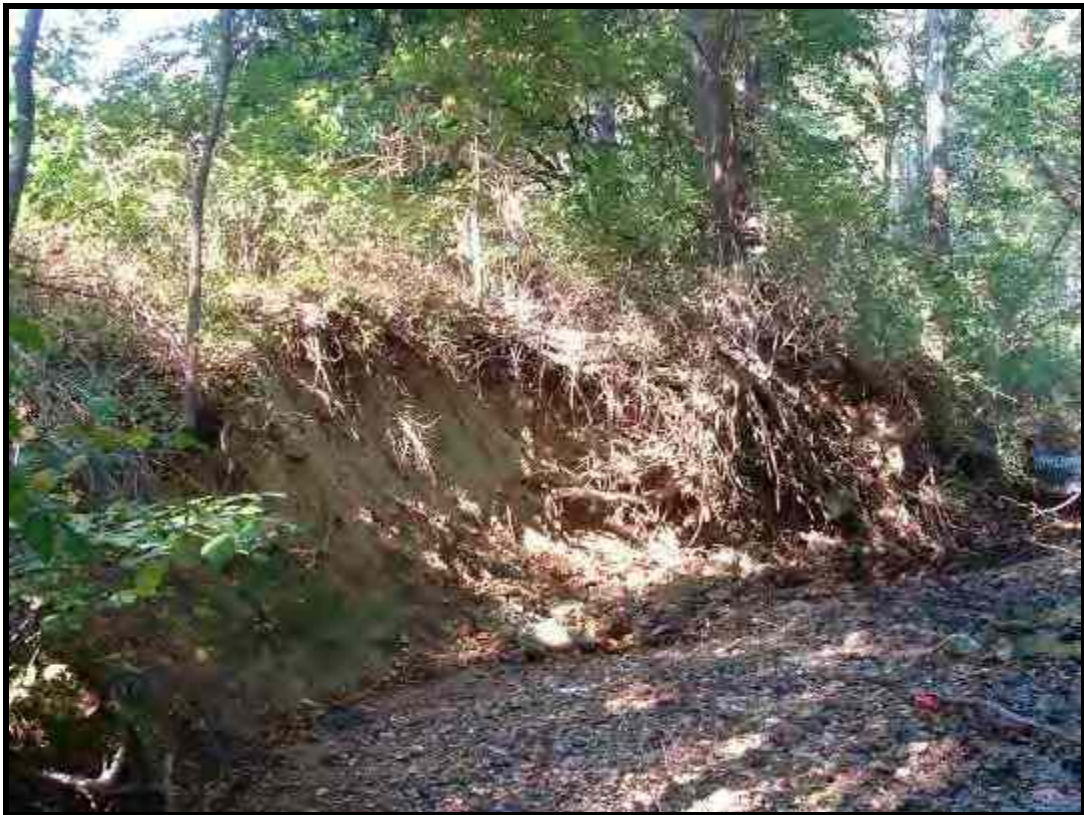
Photo 28 – Downstream view of an eight-foot high eroding streambank located directly adjacent to Jackson Boulevard
